Friends of the Tay Watershed Association

Perth E-Coli Testing Program Phase 3 Sept. 2014

Perth E-Coli Testing Program, Phase 3, Sept. 2014

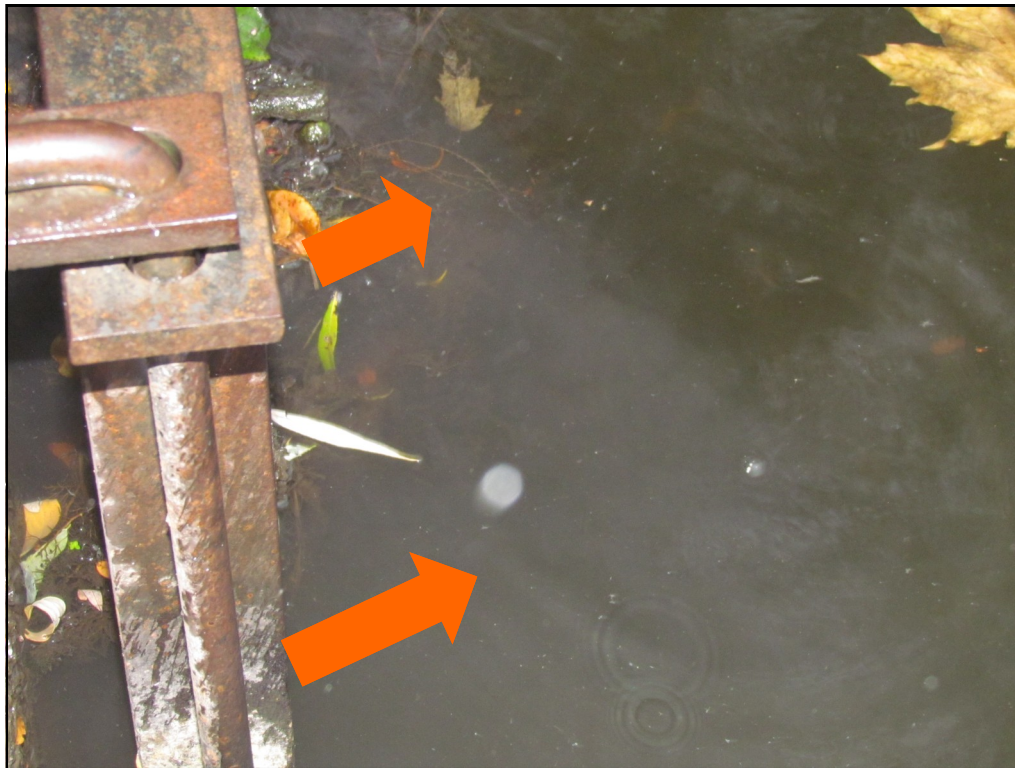
All of the previously elevated E-Coli counts had returned to levels close to or within the 100 units limit by 24 hours after the rain had stopped. By then the Big Ben (Wilson St. West) outflow had not yet cleared up to the same extent as at the Gore Street outflow where counts had initially been twice as high. Also, it appears that this outflow pipe structure may be in disrepair as it is now leaning into the downstream direction (see photo on preceding page). There is erosion behind this structure where stormwater has been observed flowing out of both sides, exiting before the end of pipe.

Big Ben outflow after one hour of light rain. Cloudy areas indicated by arrows are untreated storm water.
